MACHINING TECHNIQUE & ENGINE RECONDITIONING

*High performance
machining solutions
for valve seats and
valve guides*

***Cavitation damage
behind watercooled
exhaust seats?***

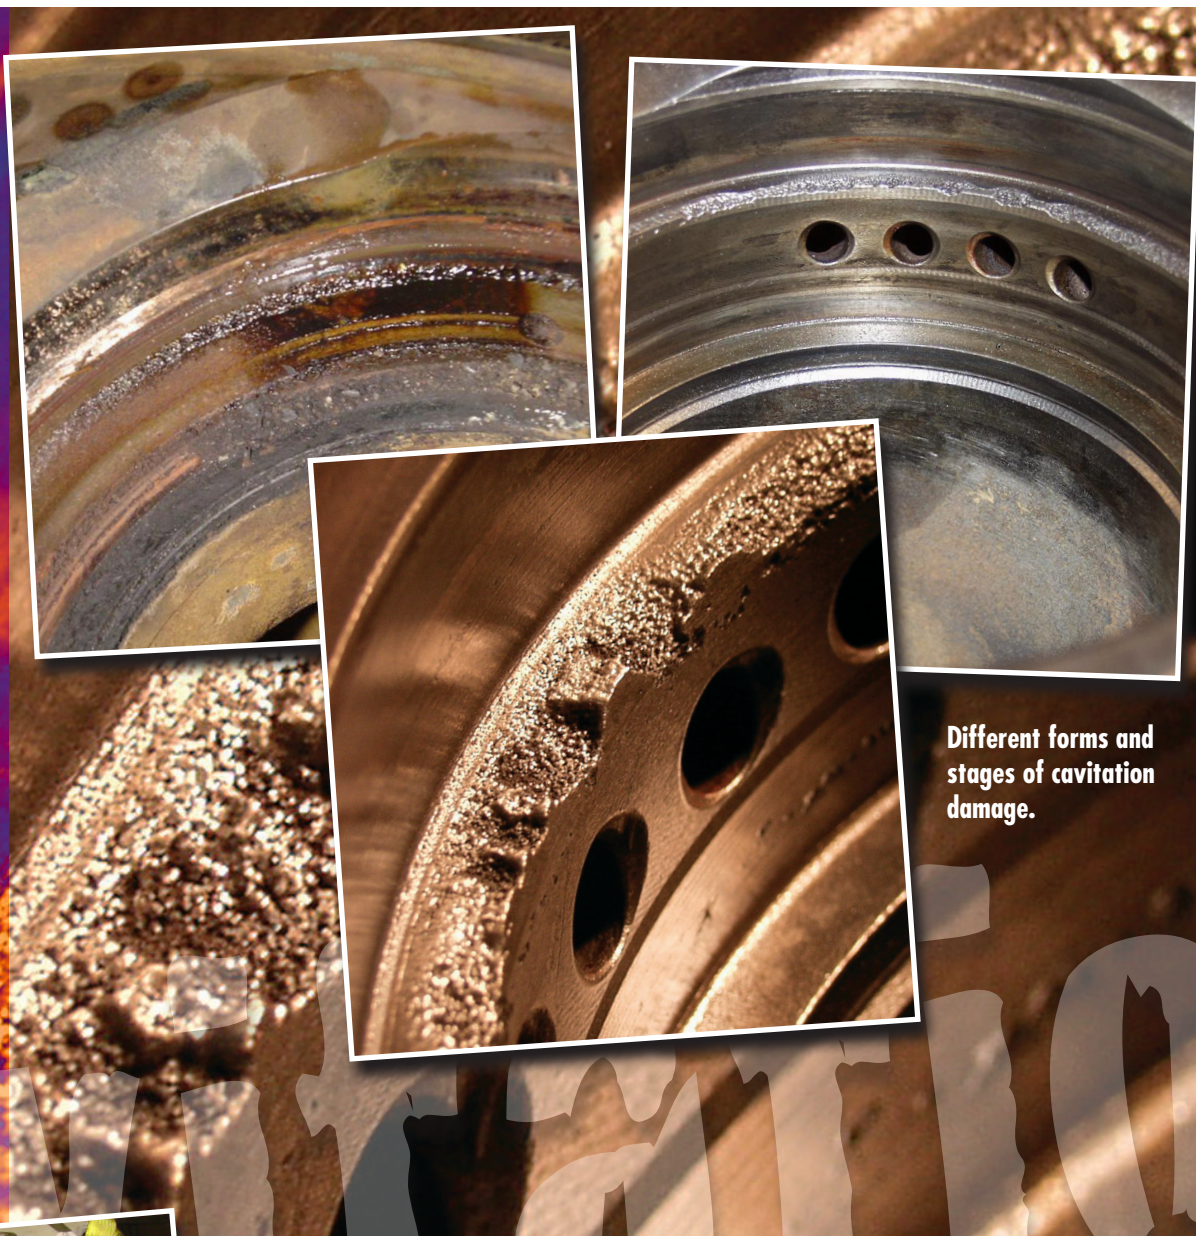
Different forms and stages of cavitation damage.

It is one of the most expensive nightmares that can happen to your engine: extensive cavitation damage!

Slowly but surely - over time - (sea)water eats away the rims and inner linings of your engine valves. Difficult to see, even more difficult to reach. Let alone to repair that with an oversized valve seat!

Unfortunately it is not possible to mount an oversized valve seat when the pocket is too seriously damaged...

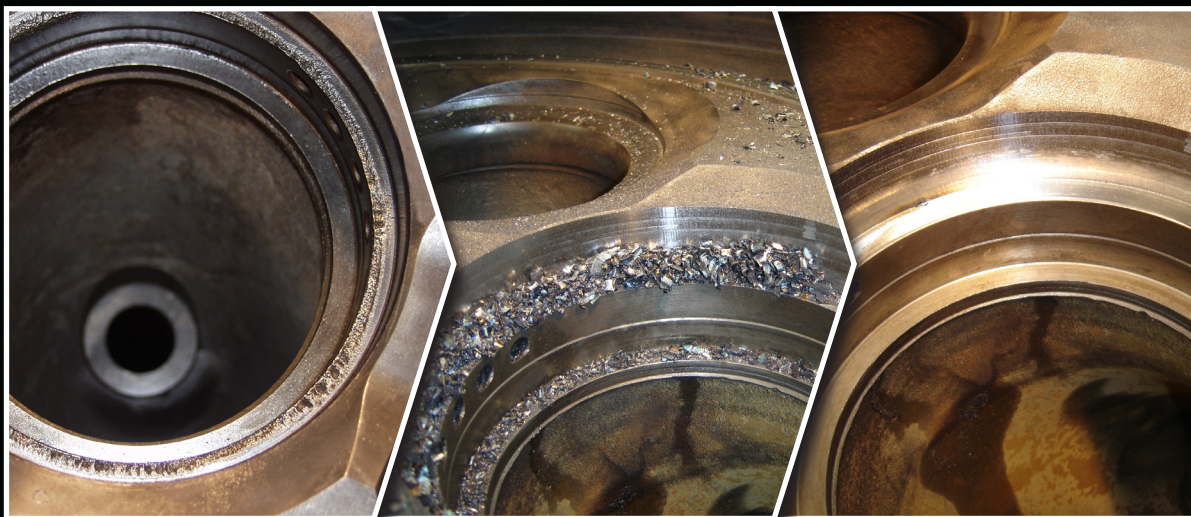
STEP 1: Cavitation damage removal procedure

Before

During the process

After

First the cavitation damage has to be removed during a CNC machined process to which the centre line of the valve guide functions as the major reference line for the CNC machining procedure.

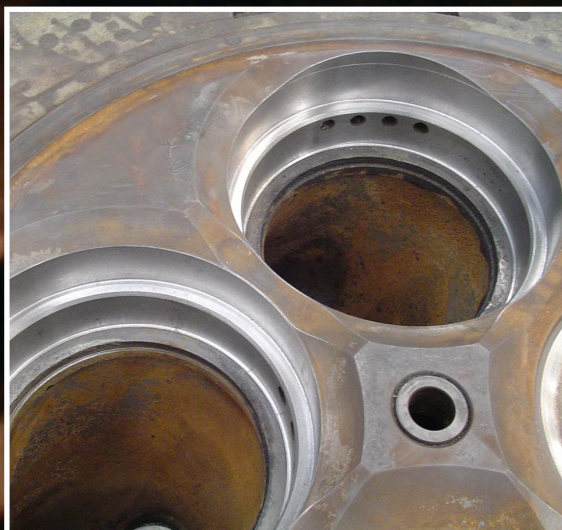
Stage 1

The process is simply described by fitting specifically designed and produced valve inserts, also called 'sleeves' inside the damaged valve pocket.

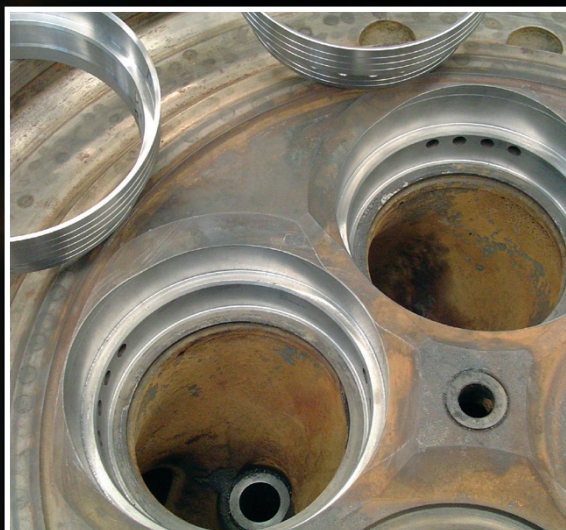
Stage 2

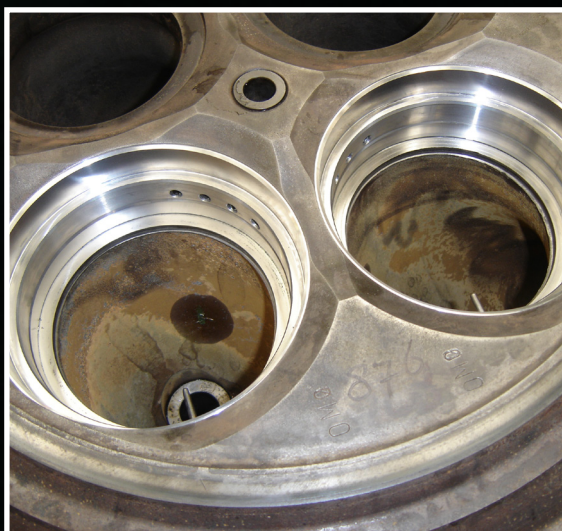
Stage 3

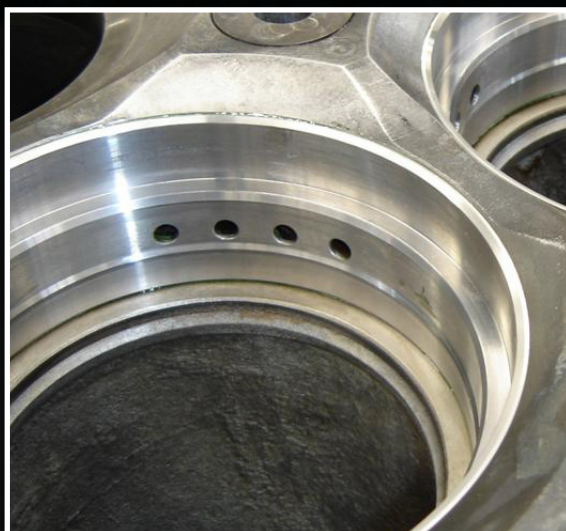
(close up)
